# **Arboricultural Impact Assessment**

***Birchwood High School, Parsonage  
Lane, Bishops Stortford CM23 5FA  
(Access Options)***

Project Number: P3105.3.0

Date: 16 March 2020

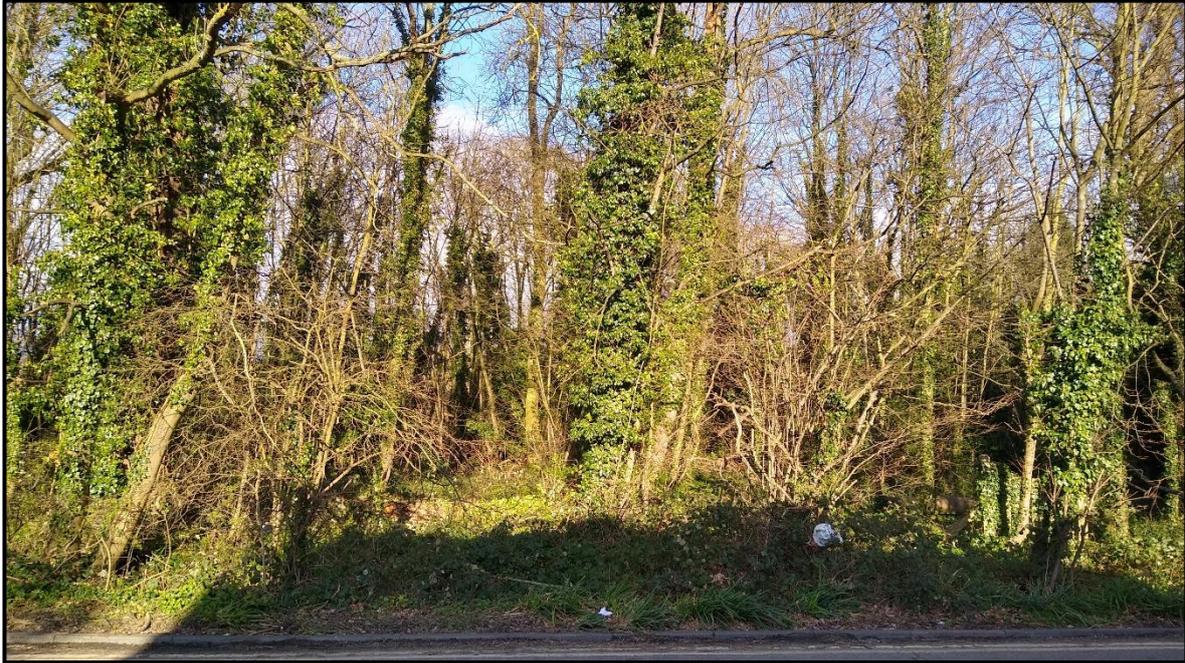
**Photograph 1 (above).** View of the southern edge of woodland, as viewed from Raynham Road, showing dense tree cover.

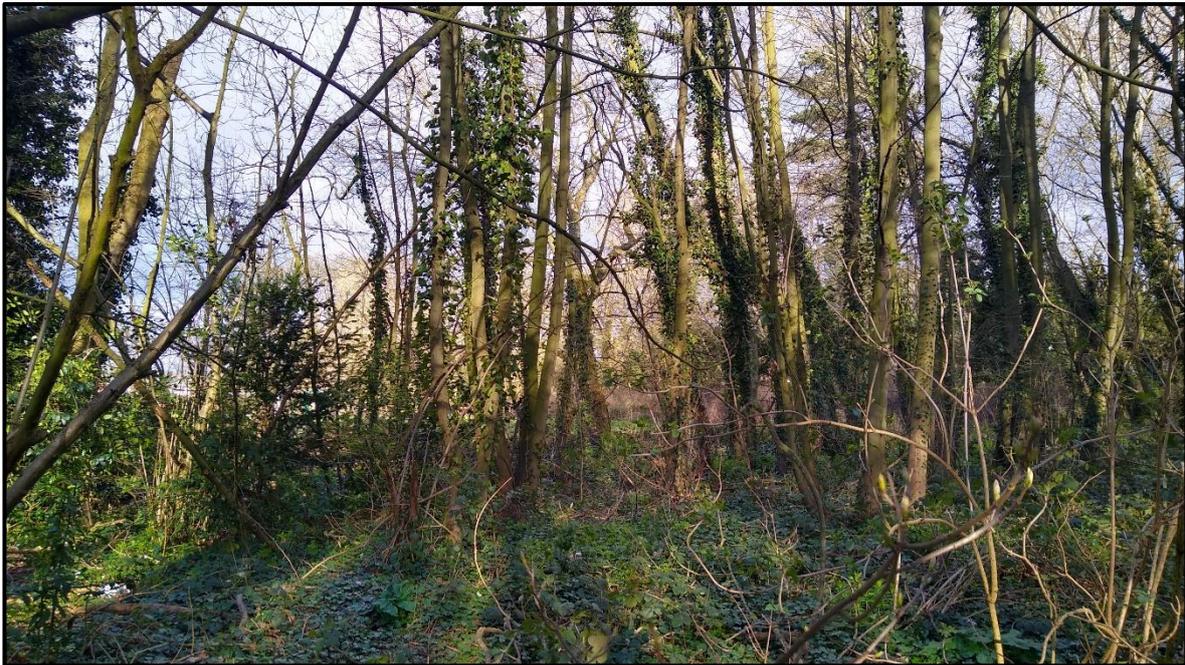
Photograph 2. Internal view within the southern woodland, showing dense tree cover.

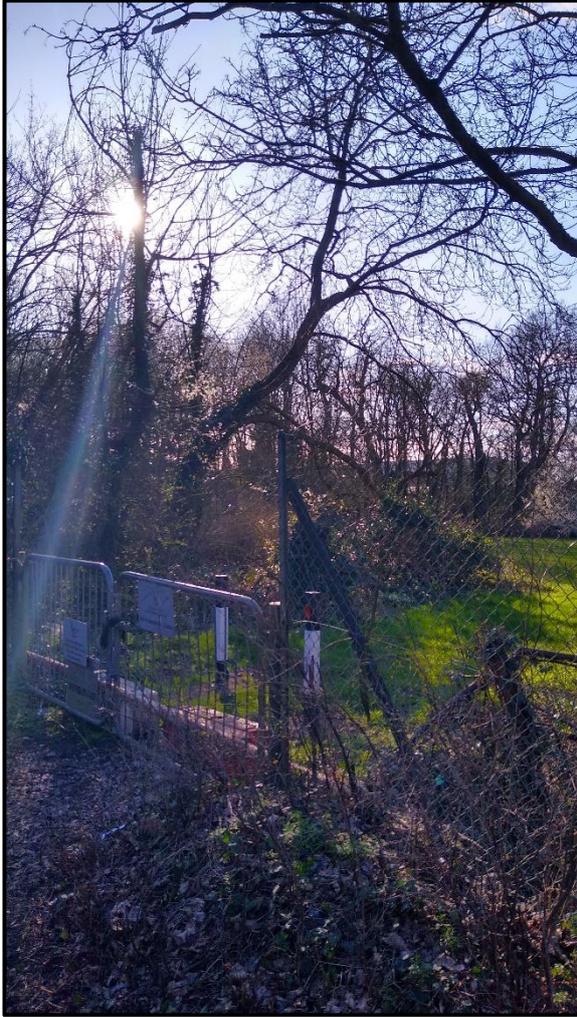
**Photograph 3.** View of the maintenance access on Dunmow Road, showing the current gap between trees and small trees to the south that may require removal if the access is widened.

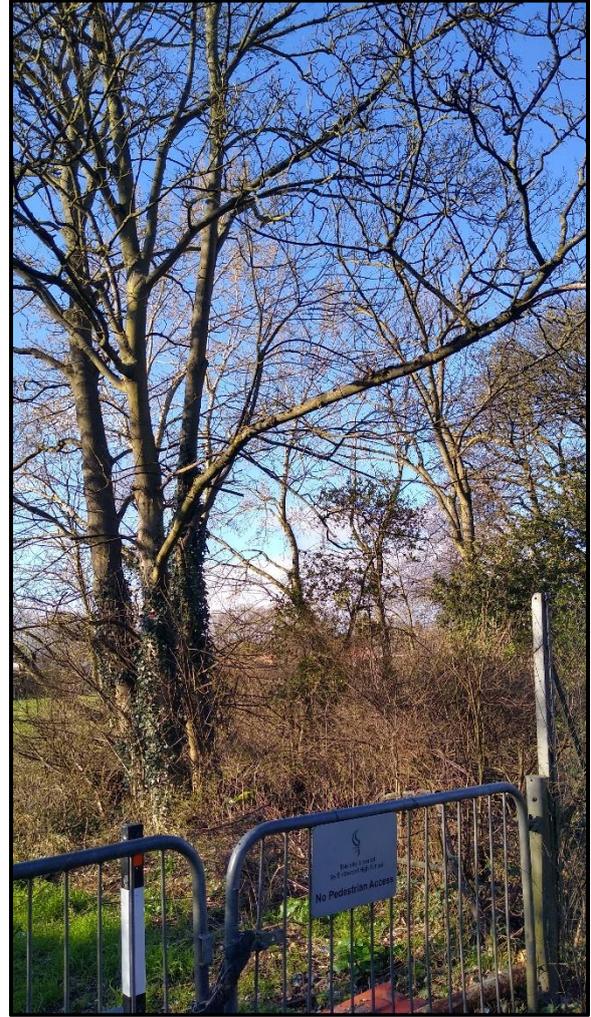
**Photograph 4.** View of the maintenance access on Dunmow Road, showing small trees to the north that may require removal if the access is widened.

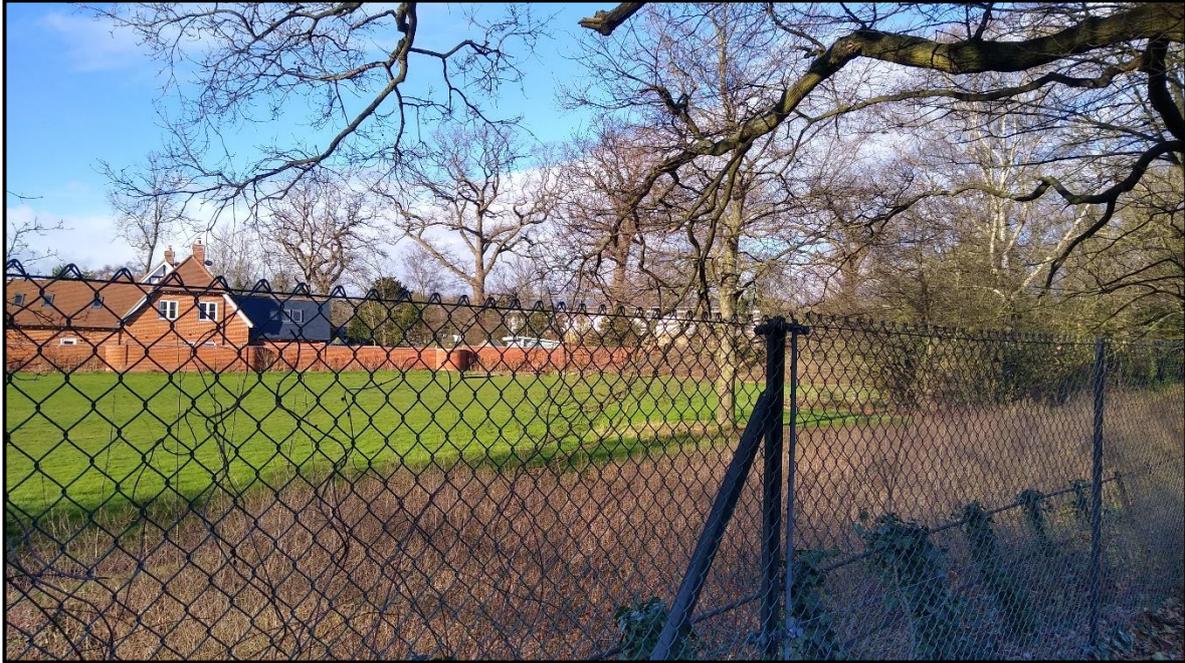
**Photograph 5 (above).** View of the more open section of G2 along Dunmow Road, with opportunities for a new access with minimal tree removal.

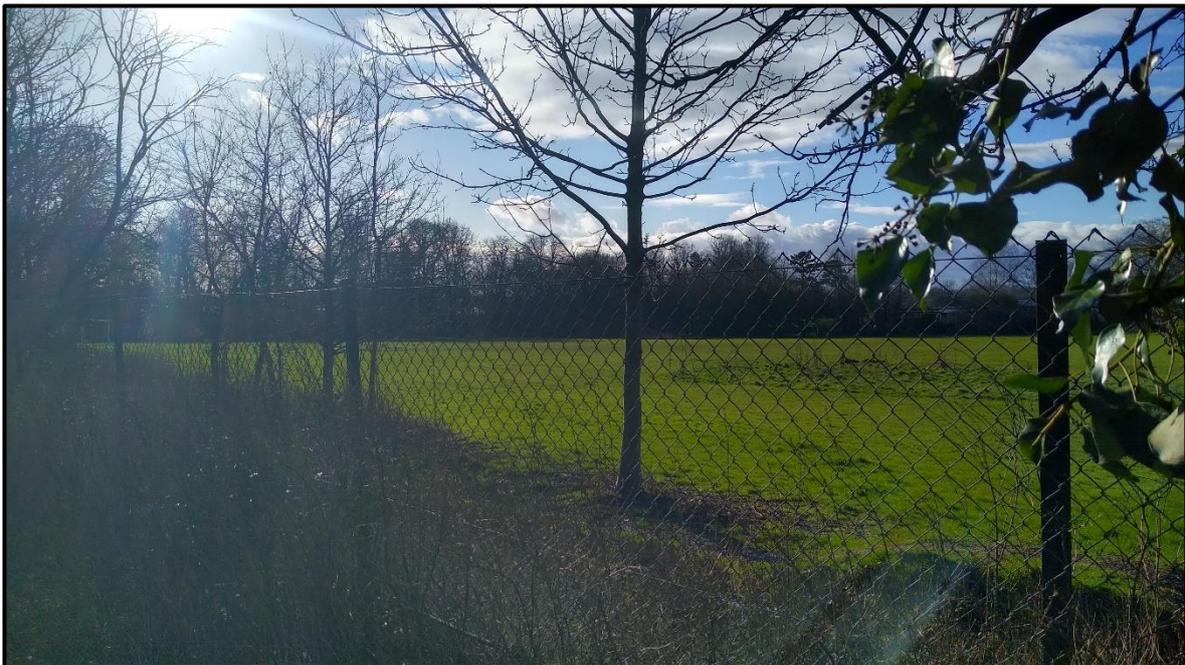
**Photograph 6.** View of the more open section of G2 along Dunmow Road, with opportunities for a new access with minimal tree removal.

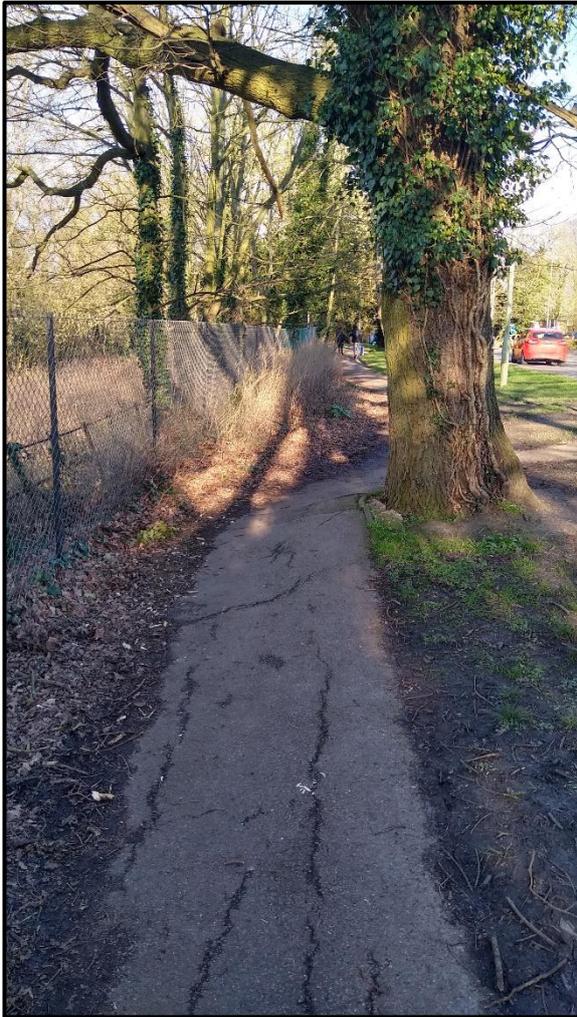
**Photograph 7.** View looking north along Dunmow Road showing the path around T2 and how it drops to the north of the tree, providing scope for the use of reduced dig techniques for a new access.

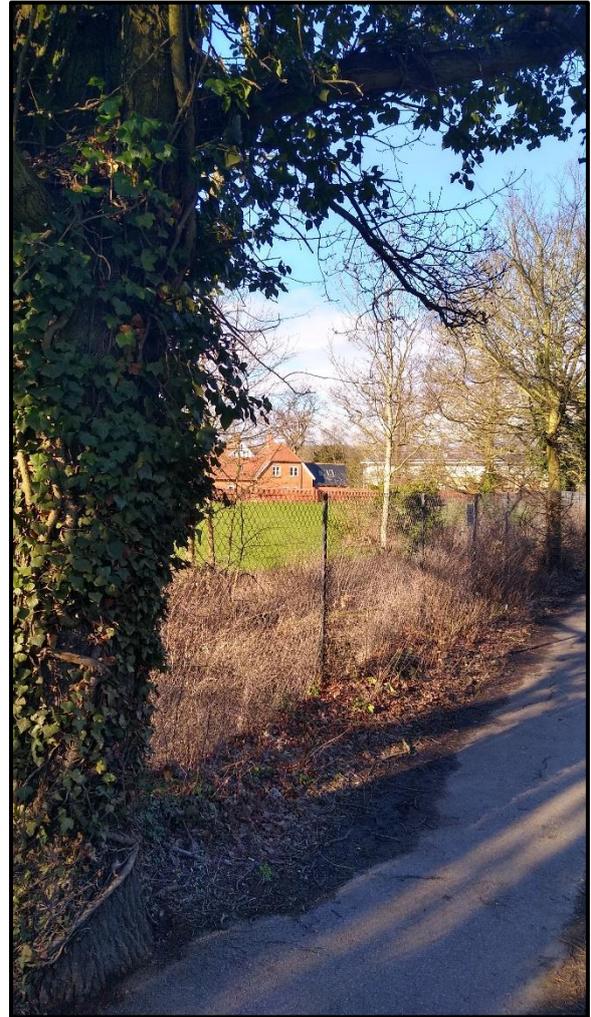
**Photograph 8.** View of part of G2 just north of T2, showing slightly more open nature of tree cover.

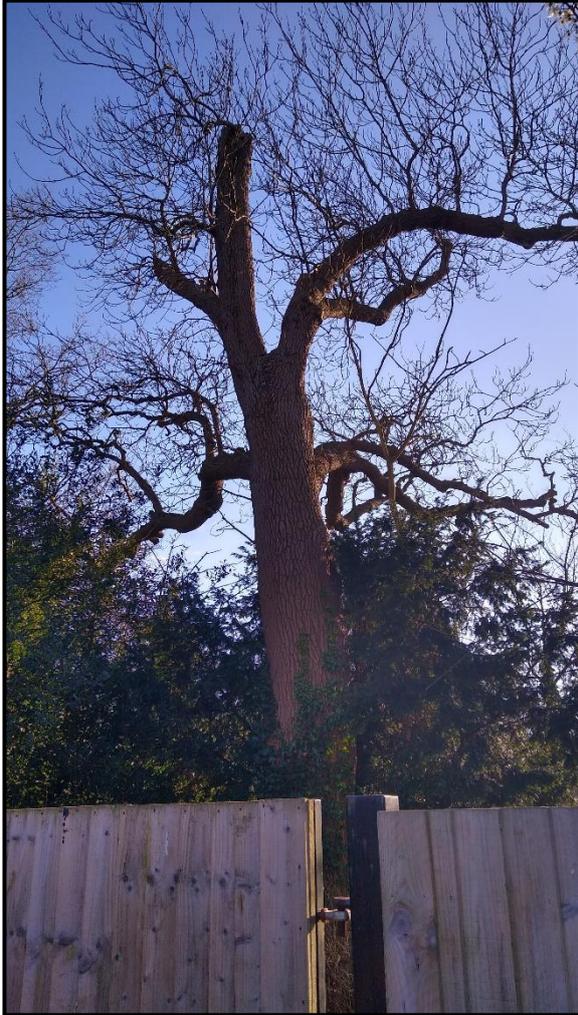
**Photograph 9.** The ash tree in G1 that would need to be removed if the new exit is located here.

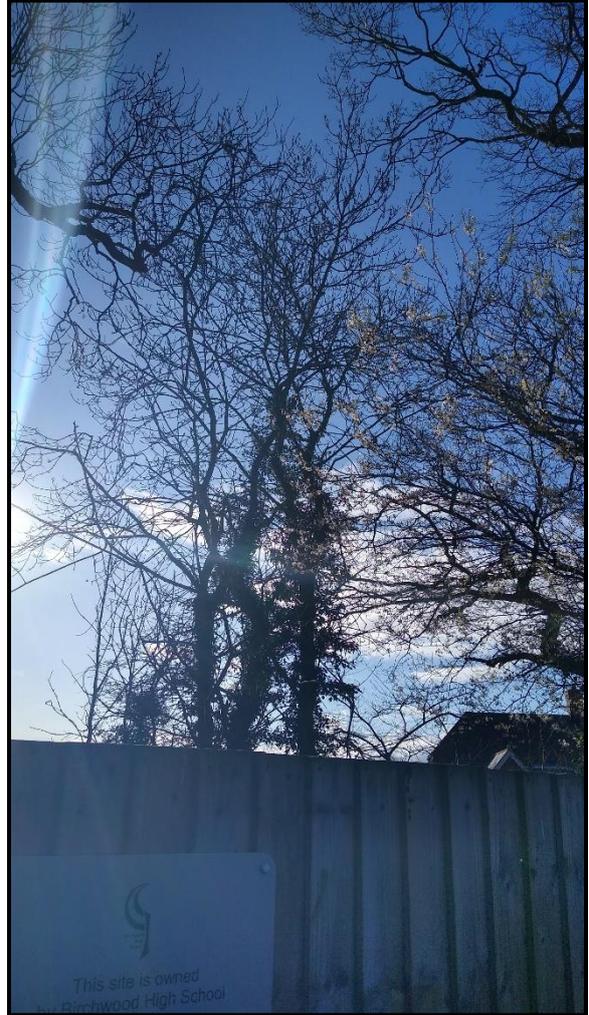
**Photograph 10.** Smaller trees close to the potential exit onto Parsonage Lane, which would also require removal.
